# **Hazardous Building Materials Assessment Report**

**710034 RR65**

**County of Grande Prairie, Alberta**

**Enviro Pros Consulting**

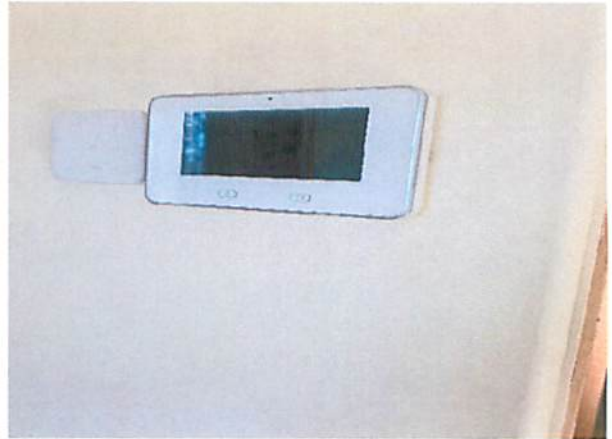
Thermostat/Alarm System

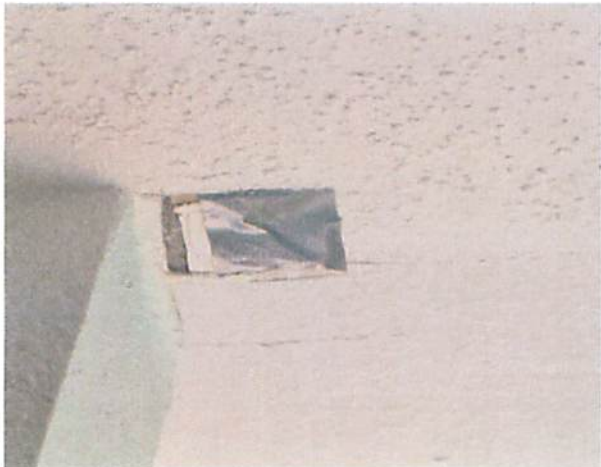
<b>Sample #</b>	<b>Location</b>	<b>Material</b>	<b>Result</b>
1.	Ceiling Basement	Ceiling Stucco	None Detected
2.	Kitchen	Lino	None Detected
3.	Basement Bathroom	DWJC	None Detected

Ceiling Texture in Basement

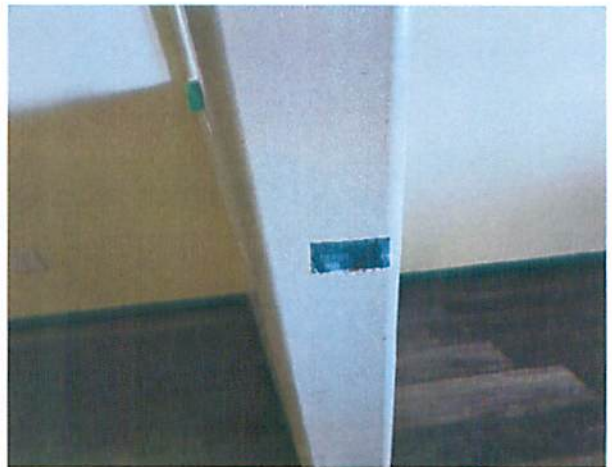
4.	Basement Den by Stairs	Vermiculite	None Detected
5.	Laundry Closet	DWJC	None Detected
6.	Green Wall Basement	DWJC	None Detected

Green Wall DWJC

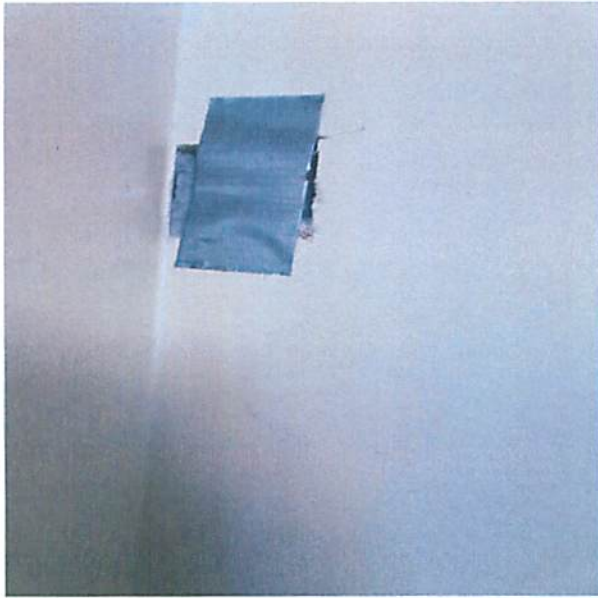
DWJC Bathroom

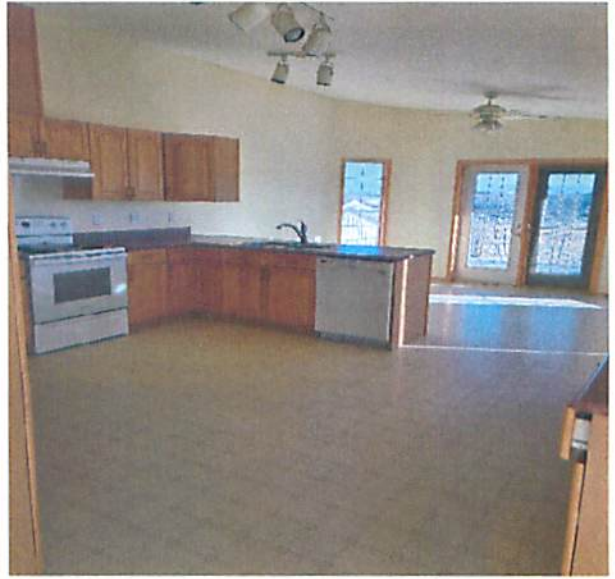
Lino Kitchen

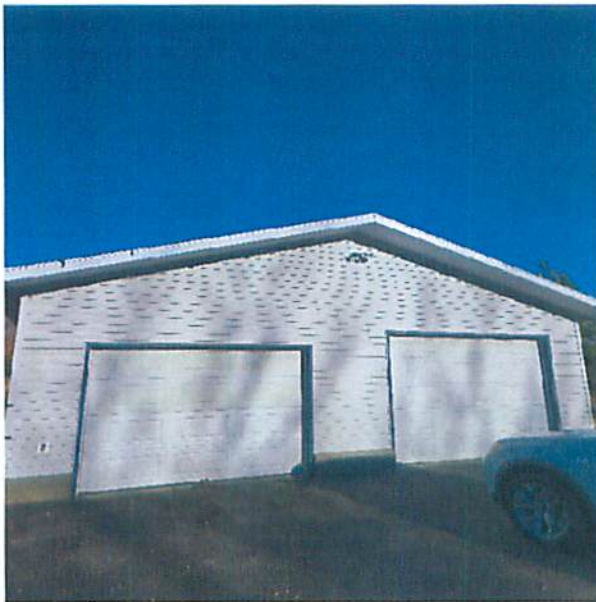
Garage

The presence of mould was observed on plywood walls in the garage. Recommend that the bottom 4 feet of plywood be removed. Other unseen mould could be exposed during work activities. Effective respiratory protection should be utilized by workers.

- The visible presence of mould on some of the garage walls dictate that effective respiratory protection be utilized by workers (ie P100 filtered half mask) during renovations.

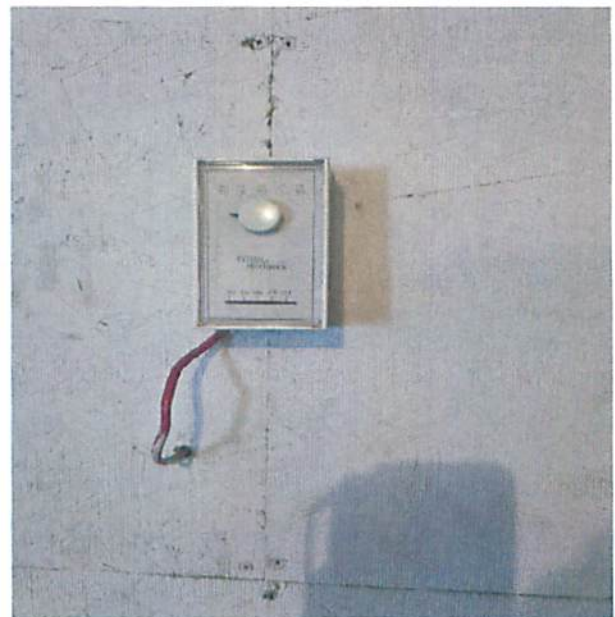
Thermostat in the garage is potentially mercury containing

- Potential mercury containing thermostat noted. Appropriate disposal is required if the disposal of the thermostat is necessitated

Mercury Thermostat
