Hazardous Building Materials Assessment Report

713034A RR70

County of Grande Prairie, Alberta

The hazardous building materials assessment was conducted on November 14, 2025, by Wesley Huett of **Enviro Pros Consulting**. The assessment and sampling were conducted on behalf of Mark Hand from **Transportation Economic Corridors**.

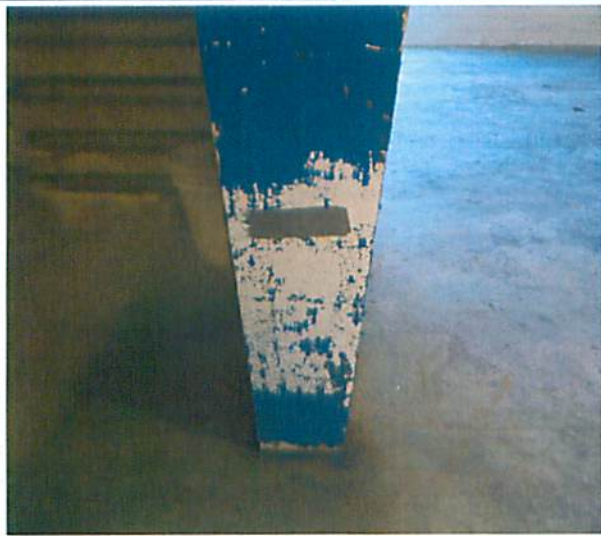
Blue Paint on wall and stairs

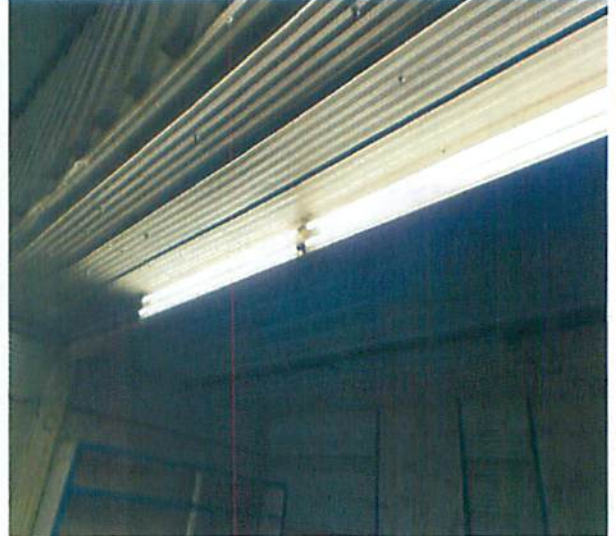
Florescent light tubes potentially containing mercury were observed. Appropriate disposal measures must be undertaken if those are discarded.

Fluorescent Lights

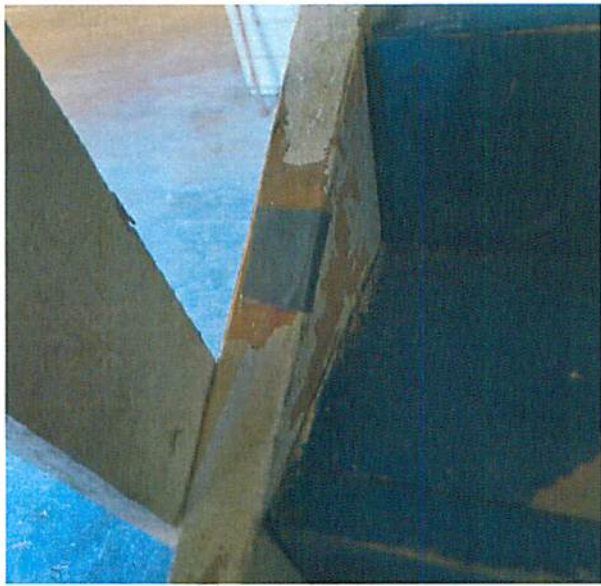
White Paint on rails of stairs

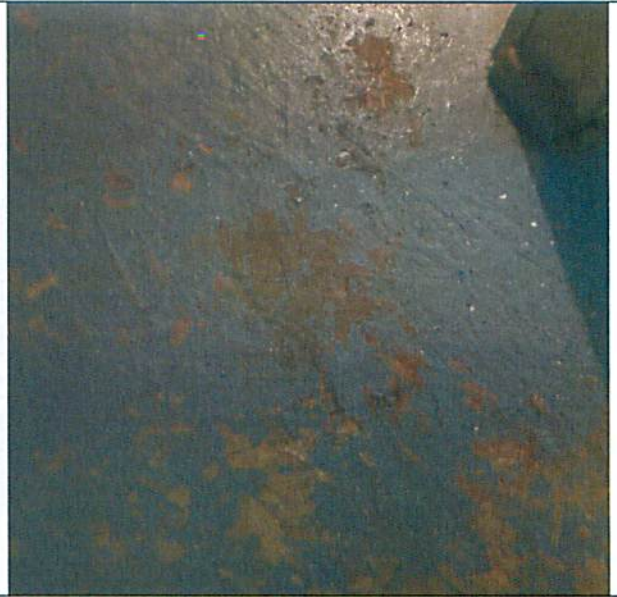
Grey Paint on floor o Mezzanine

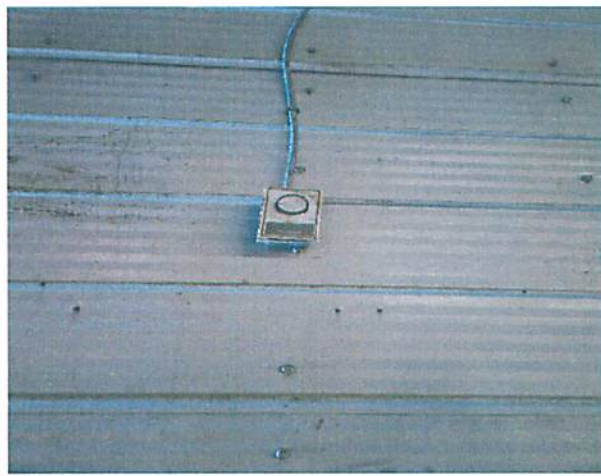
- A potential mercury containing thermostat was noted. Appropriate disposal should be undertaken if disposal is part of the scope.

Potential Mercury Thermostat

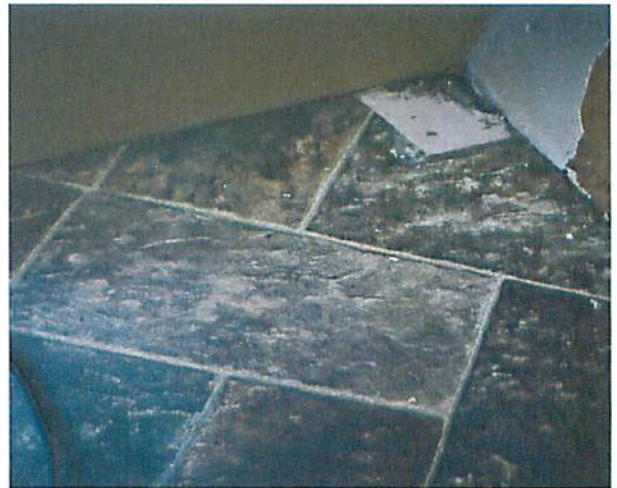
Lino Flooring in Kitchen

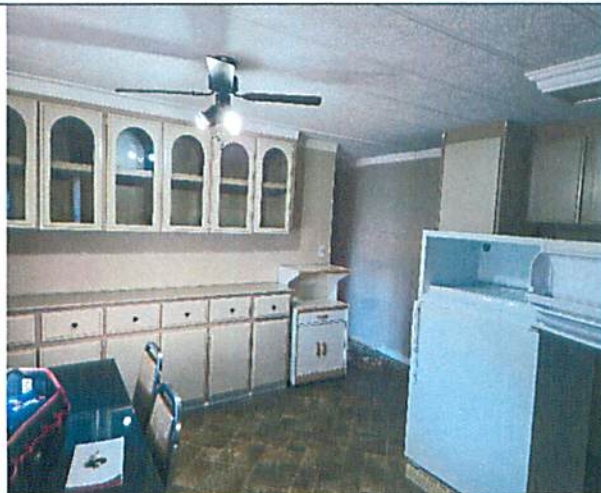
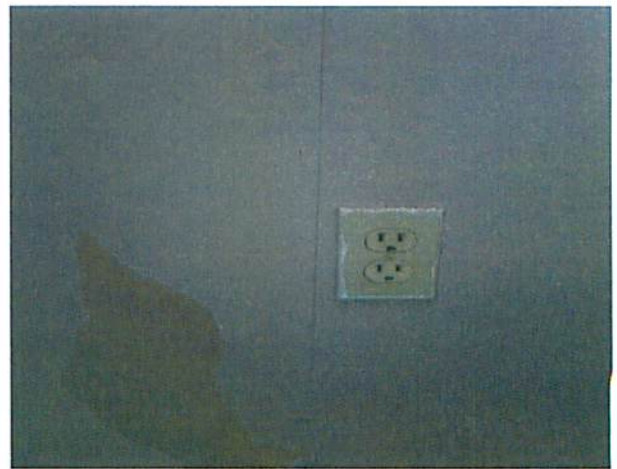
2 different beige color paints on cupboards

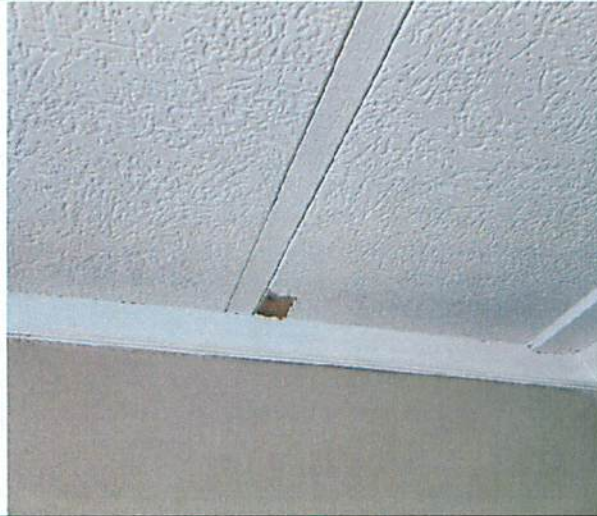
Ceiling Texture

Light Beige Paint on walls
