Hazardous Building Materials Assessment Report

710034 RR65

County of Grande Prairie, Alberta

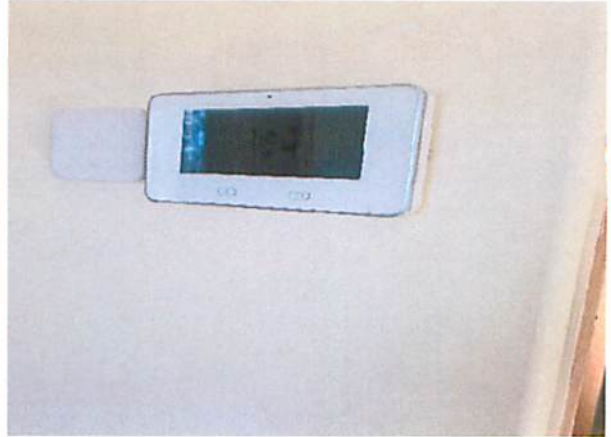
Thermostat/Alarm System

Thermostat in the garage is potentially mercury containing

- Potential mercury containing thermostat noted. Appropriate disposal is required if the disposal of the thermostat is necessitated

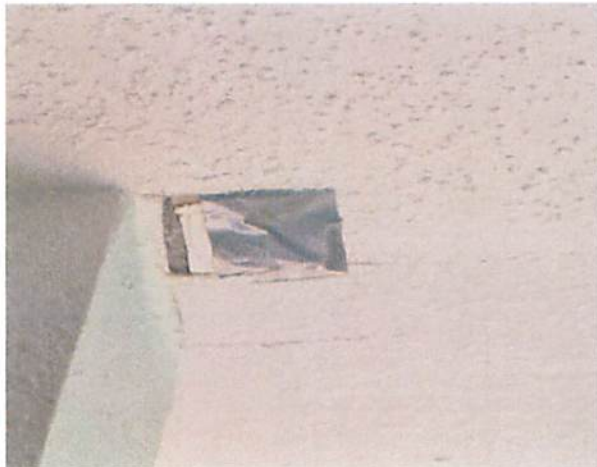
Ceiling Texture in Basement

| Sample # | Location | Material | Result |
|---|---|---|---|
| 1. | Ceiling Basement | Ceiling Stucco | None Detected |

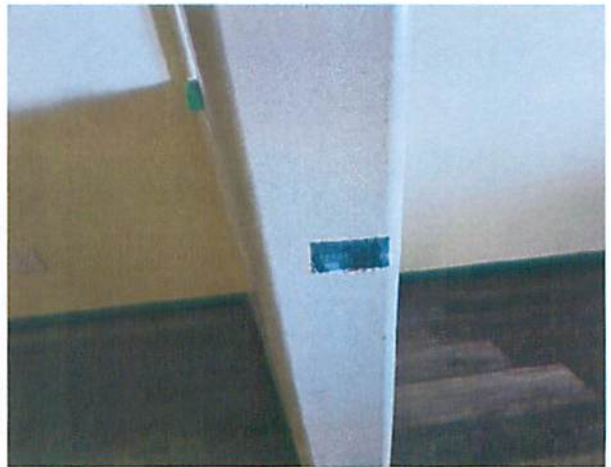
Green Wall DWJC

| 6. | Green Wall Basement | DWJC | None Detected |

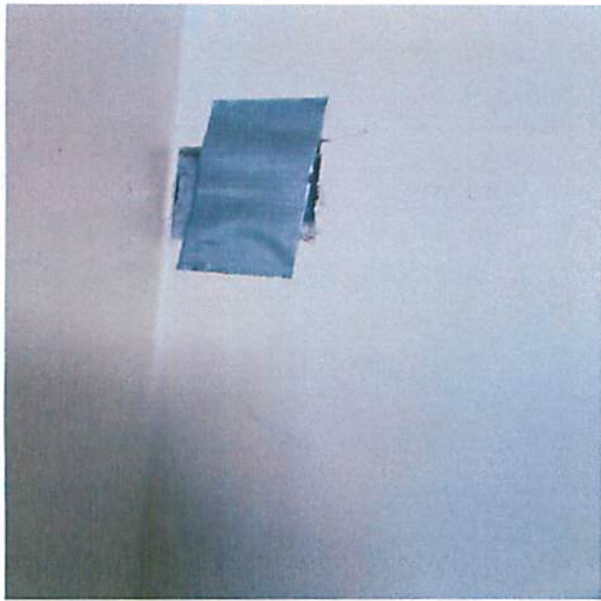
DWJC Bathroom

| Sample # | Location | Material | Result |
|---|---|---|---|
| 3. | Basement Bathroom | DWJC | None Detected |

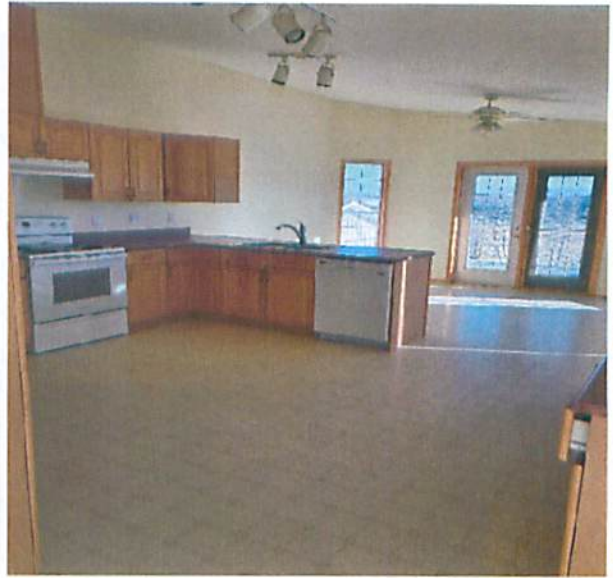
Lino Kitchen

| Sample # | Location | Material | Result |
|---|---|---|---|
| 2. | Kitchen | Lino | None Detected |

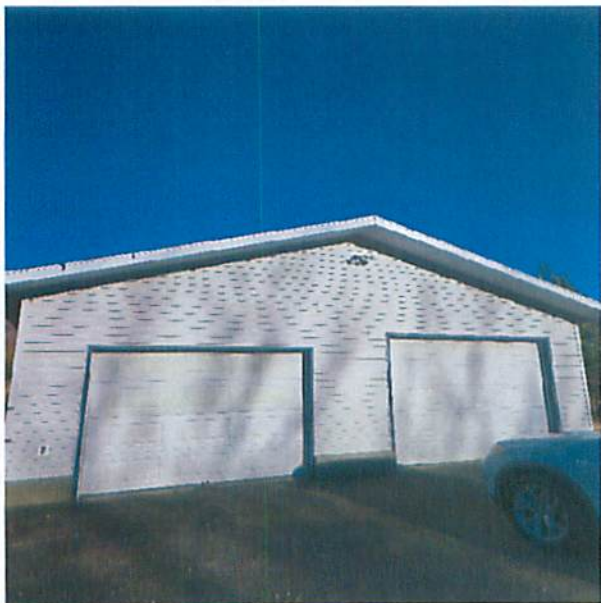
Garage

The presence of mould was observed on plywood walls in the garage. Recommend that the bottom 4 feet of plywood be removed. Other unseen mould could be exposed during work activities. Effective respiratory protection should be utilized by workers.

- The visible presence of mould on some of the garage walls dictate that effective respiratory protection be utilized by workers (ie P100 filtered half mask) during renovations.
