| Subject | Hazardous Material<br>Assessment |
| Site Address | 100C Mackenzie Rd.<br>Fort Chipewyan, Alberta |
| For | Alberta Forestry and Parks |
| Inspection Date | August 13, 2026 |

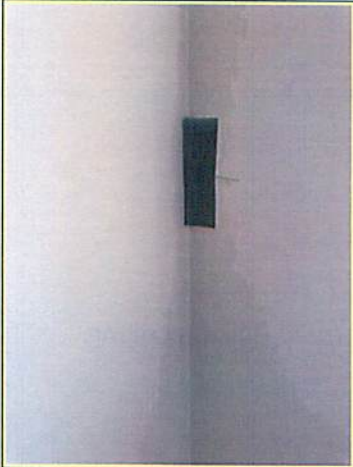
| Sample ID | Sample Location / Description | Material / Appearance | Asbestos Result | Photographs |
|---|---|---|---|---|
| A005 | Bedroom 3 walls | Joint compound / Beige | 2% Chrysotile | |

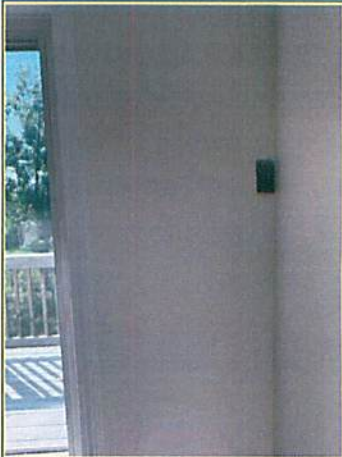
| Sample ID | Sample Location / Description | Material / Appearance | Asbestos Result | Photographs |
|---|---|---|---|---|
| A006 - JDWC 2 | Living room walls | Joint compound / Beige | 2% Chrysotile | |

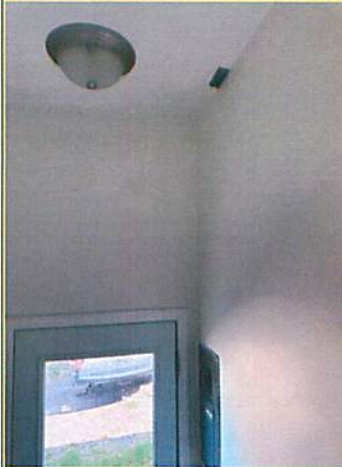
| Sample ID | Sample Location / Description | Material / Appearance | Asbestos Result | Photographs |
|---|---|---|---|---|
| A007 | Main ceiling | Joint compound / Beige | 2% Chrysotile | |

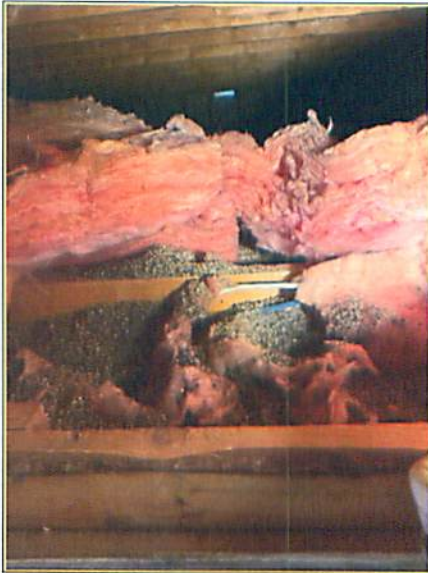
| Sample ID | Sample Location / Description | Material / Appearance | Asbestos Result | Photographs |
|---|---|---|---|---|
| Vermiculite Sample | Vermiculite insulation | Vermiculite / Various-Gold | <1% Actinolite | |

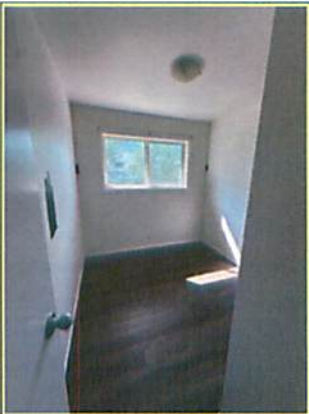
| Sample ID | Sample Location / Description | Material / Appearance | Analyzed Weight (g) | Lead Result | Photographs |
|---|---|---|---|---|---|
| L005 | Bedroom 3 | White painted surface | 0.2547 g | 1,000 ppm | |

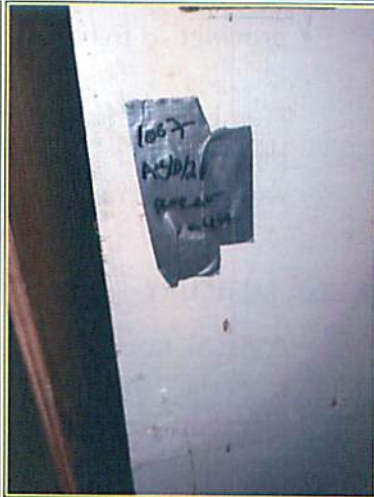
| Sample ID | Sample Location / Description | Material / Appearance | Analyzed Weight (g) | Lead Result | Photographs |
|---|---|---|---|---|---|
| L007 | Basement furnace | White painted surface | 0.2623 g | 970 ppm | |

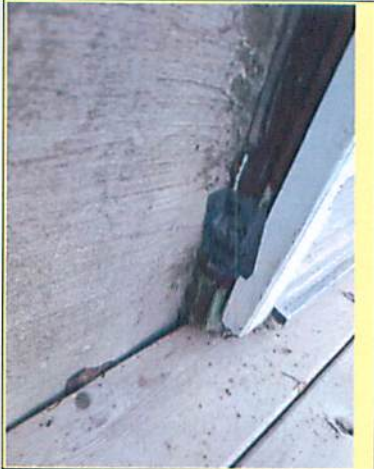
| Sample ID | Sample Location / Description | Material / Appearance | Analyzed Weight (g) | Lead Result | Photographs |
|---|---|---|---|---|---|
| L009 | Exterior trim | Brown painted surface | 0.2628 g | 4,300 ppm | |

The highest reported lead concentration was 4,300 ppm in Sample L009, Exterior Trim - Brown, followed by 1,000 ppm in L005, Bedroom 3 - White, and 970 ppm in L007, Basement Furnace – White. A copy of the independent laboratory analytical report is provided in the Appendices for reference.

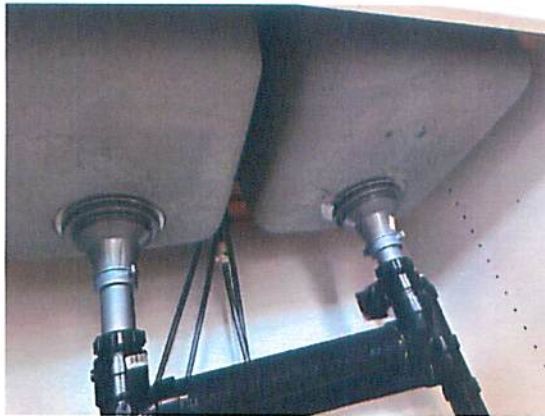
Photograph of underside of kitchen sink for possible asbestos coatings. None found. August 13, 2026

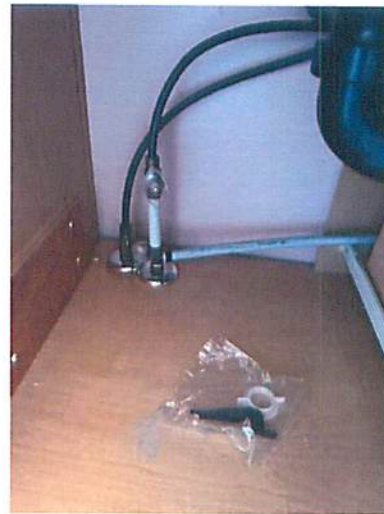
Photograph of lack of cleaning supplies or solvents/ miscellaneous chemicals. August 13, 2026

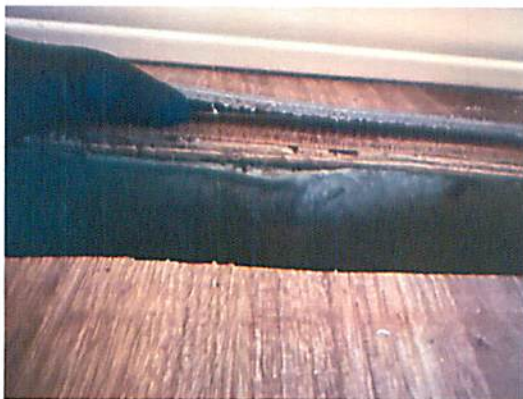
Photograph of inspection of the flooring in bathroom for stratified layers of potentially hidden ACM flooring. August 13, 2026

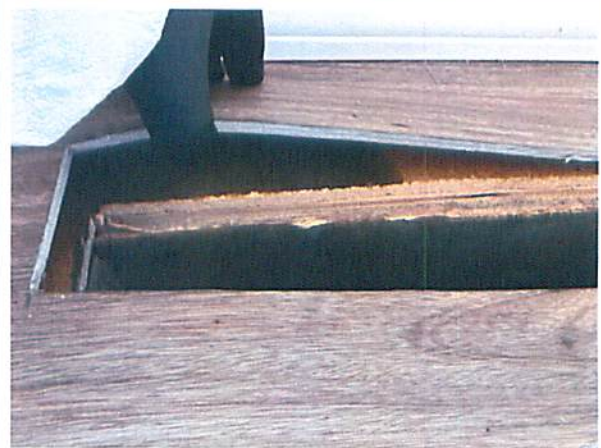
Photograph of inspection of the flooring in livingroom for stratified layers of potentially hidden ACM flooring. August 13, 2026

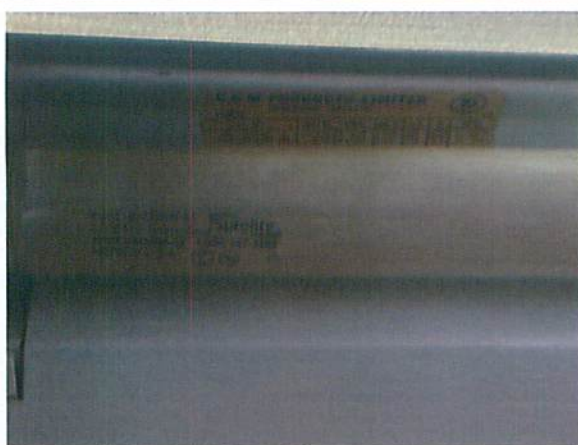
Fluorescent lighting fixtures were observed within the building. The accessible fixture identification label indicated an apparent date of 1982; however, the associated ballast did not display a clearly legible "NON-PCB," "No PCBs," or equivalent manufacturer marking confirming that the ballast was manufactured without PCBs. As the apparent date falls within the transitional period following the phase-out of PCB use in new products in Canada, the date alone is not considered sufficient evidence to conclusively establish the PCB status of the ballast. Accordingly, where manufacturer documentation or other reliable information cannot confirm that the ballast is PCB-free, the ballast should be considered suspect for PCB-containing components for management purposes until appropriately characterized or otherwise verified.

Photograph of fluorescent light tubes found in basement and ballast stickers indicating installation of 1982. August 13, 2026

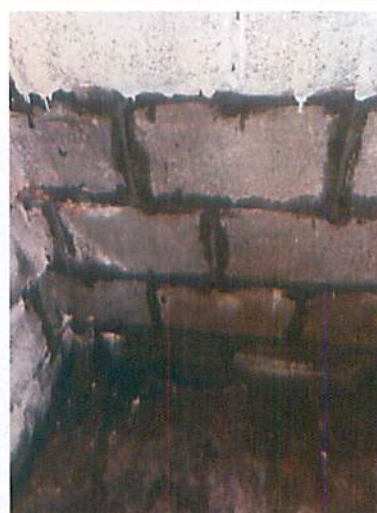
Photograph of unpainted section exposing true composition of foundation to be hempcrete blocks. Blocks were core assessed and found to be solid. August 13, 2026

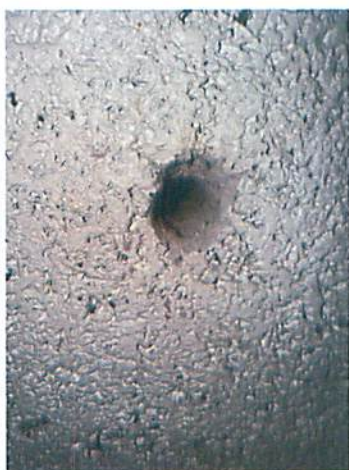
Photograph of core assessment in hempcrete blocks. Block composition turns to clay when drilling. August 13, 2026

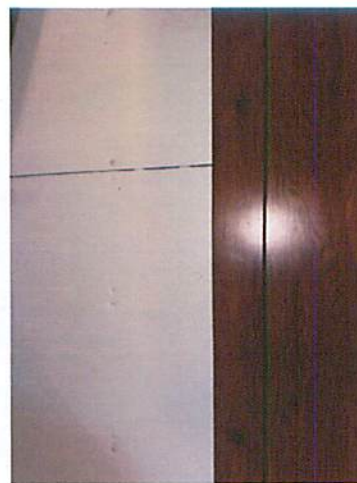
Photograph showing sections of unfinished drywall in basement behind wood panelling. August 13, 2026

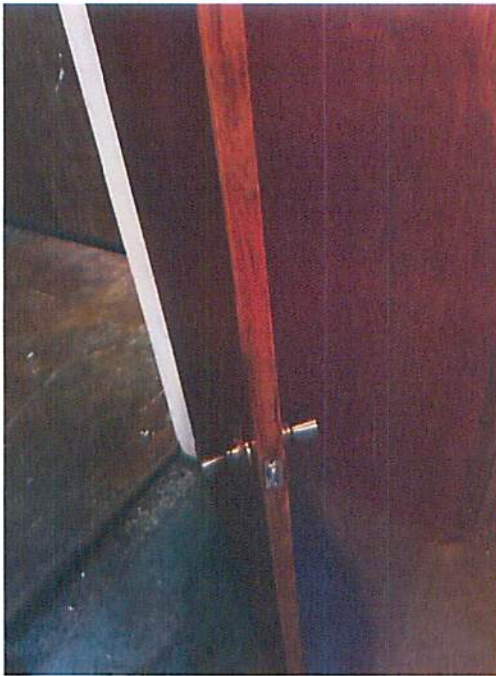
Photograph of solid wood interior doors. The doors were not observed to bear fire-rating labels or other markings indicative of a fire-rated assembly and were therefore not suspected of containing an asbestos-containing core. August 13, 2026

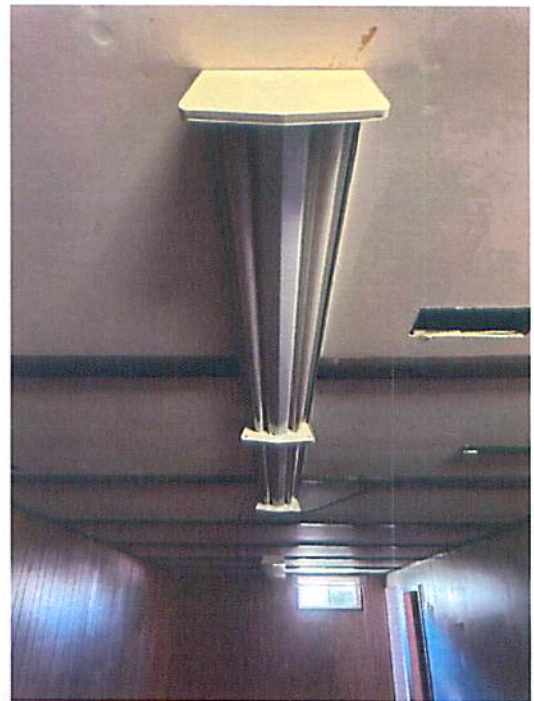
Photograph of the basement ceiling assembly showing gypsum wallboard and strapping installed over seams. Accessible wallboard seams were inspected and found to be unfinished, with no joint compound apparent along the inspected seams. Localized areas of patching were observed and were representatively sampled as part of the hazardous materials assessment to confirm asbestos content. August 13, 2026

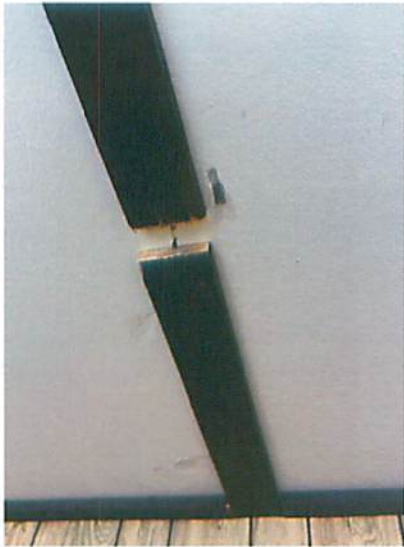
Photograph of visual inspection area of basement ceiling seams. August 13, 2026

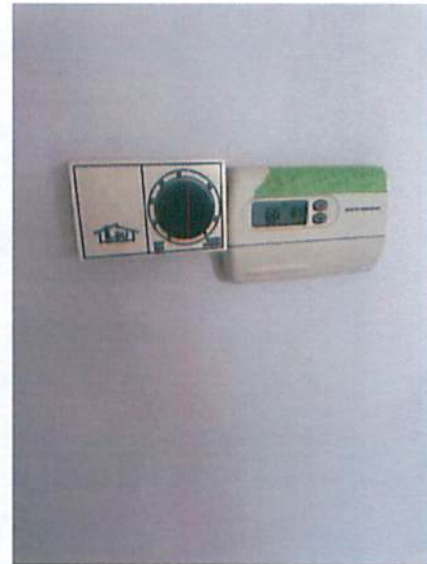
Photograph of digital thermostat. August 13, 2026

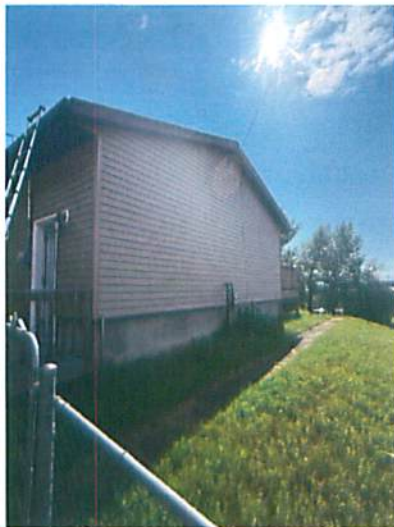
Photograph of exterior vinyl siding and Cementous parging. June23, 2026

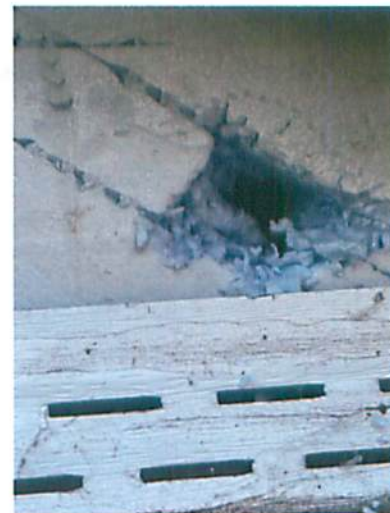
Photograph of Styrofoam insulation between sheathing and vinyl siding. Insulation section was removed to assess for possible ACM stucco exterior however only Tyvek paper on sheathing found. June23, 2026
